Manhole Inspection Summary

Manhole # S3301_017MH

Location Address: **501 Seagull Ave**

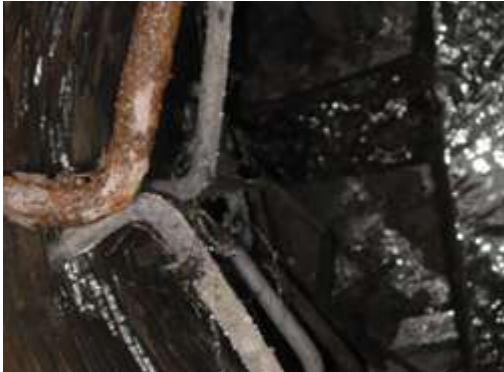
steps

Count: **8** Missing: **0** ☐ Corroded

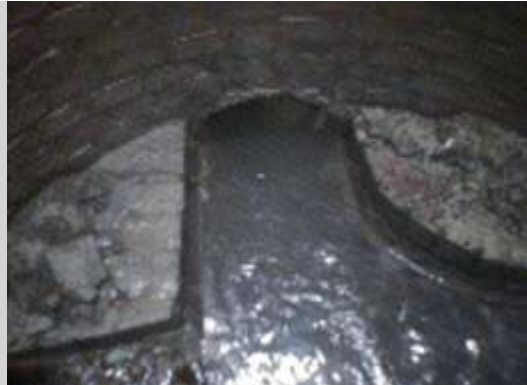
12 O'Clock Outflow

12 in. Circular Gravity Sewer
Pipe Out @ 12 O'Clock

Pipe Height: **14.4** (in.) Rod and Bar (Angled)
Pipe Material: **Clay** ☐ Pipe Lined
Invert Depth: **14.86** (ft.) Flow Characteristics: **Fast**
Deposits: ☒ None ☐ Mud ☐ Sludge ☐ Debris ☐ Grease
Silt Depth: (in.) Deposits Extent:
Infiltration: **None** Pipe Seal Cond: **Sound**

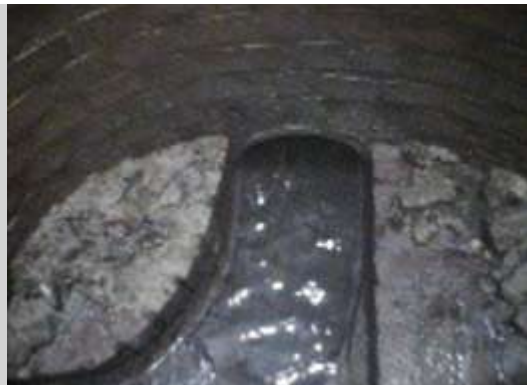
3 O'Clock Inflow

10 in. Circular Gravity Sewer
Pipe In @ 3 O'Clock

Pipe Height: **12** (in.) Rod and Bar (Angled)
Pipe Material: **Clay** ☐ Pipe Lined
Invert Depth: **14.81** (ft.) Flow Characteristics: **Fast**
Deposits: ☒ None ☐ Mud ☐ Sludge ☐ Debris ☐ Grease
Silt Depth: (in.) Deposits Extent:
Infiltration: **None** Pipe Seal Cond: **Sound**

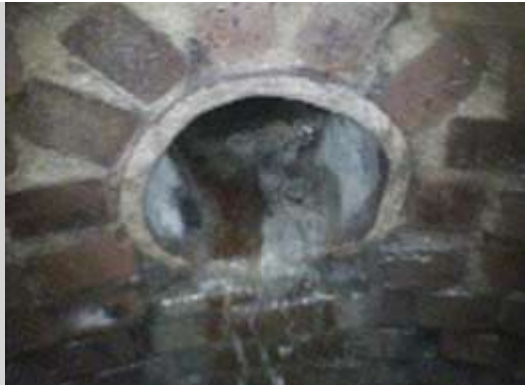
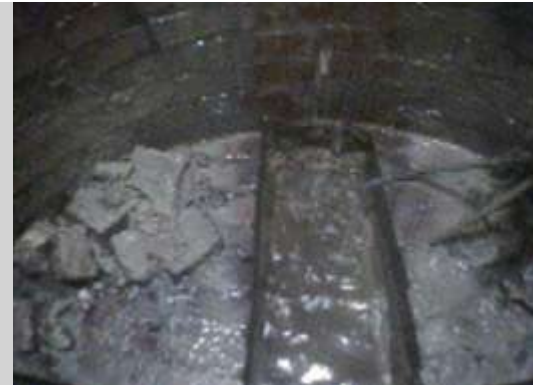
6 O'Clock Inflow

Pipe Height: **9.6** (in.) Rod and Bar (Angled)

Infiltration: **None** Pipe Seal Cond: **Sound**

Drop: **Inside** Rod and Bar
Angled: **Yes** Reading: **13.26** (ft.)
Inv Depth: **14.26** (ft.)
Drop Condition: **Open**

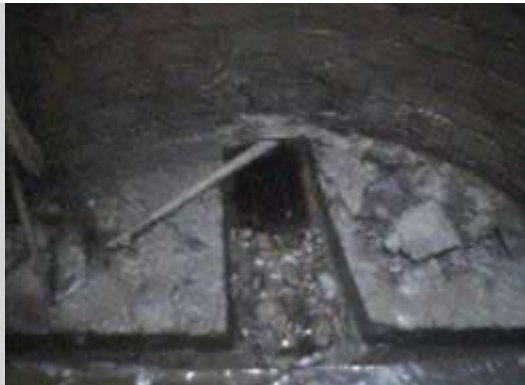
9 O'Clock Inflow

8 in. Circular Service Sewer

Invert Depth: **14.24** (ft.) Flow Characteristics: **Slow**

Deposits: ☐ None ☐ Mud ☒ Sludge ☒ Debris ☐ Grease

Silt Depth: **3** (in.) Deposits Extent: **Heavy**
